DESIGN, FABRICATION, INSTALLATION AND FLIGHT SERVICE EVALUATION OF A COMPOSITE CARGO RAMP SKIN ON A MODEL CH-53 HELICOPTER

SIKORSKY AIRCRAFT
DIVISION OF UNITED TECHNOLOGIES CORPORATION
Stratford, Conn.

CONTRACT NO. NAS1-14447
APRIL 1983

Langley Research Center
Hampton, Virginia 23665

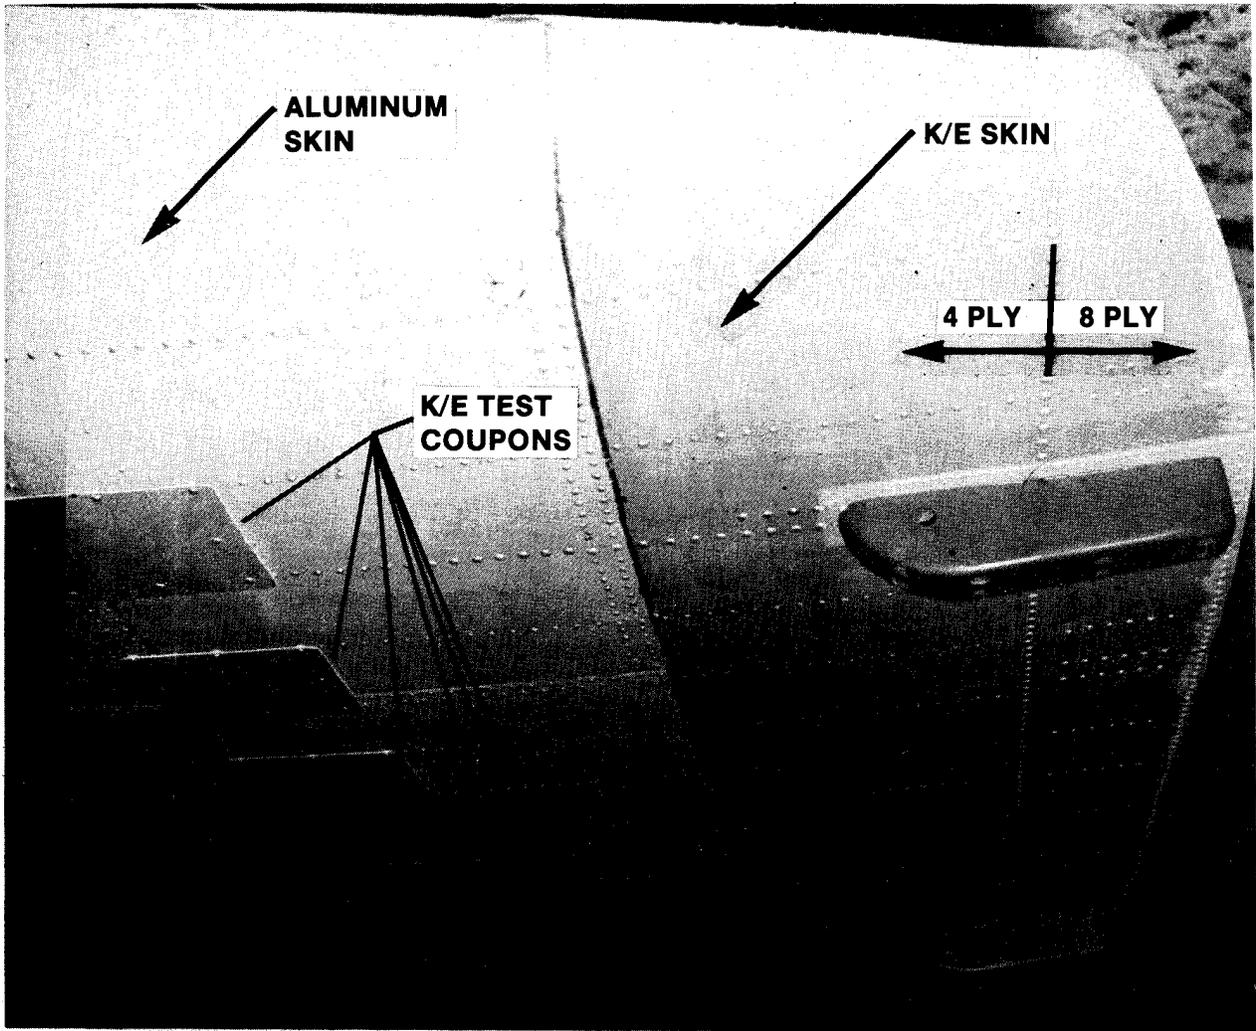
The first field inspection of the Kevlar skin panel was conducted in December of 1982. At that time, the Kevlar skin appeared to be in good condition. One Kevlar coupon was removed and sent to NASA Langley. At the end of each year, one (1) coupon will be removed and sent to NASA for testing. Total flight time of the aircraft with the modified ramp installed was 382.9 hours.

FIGURE 8 COMPLETED RAMP WITH KEVLAR/EPOXY SKIN PANEL AND TEST COUPONS INSTALLED. (PHOTO COURTESY OF U.S. NAVY)

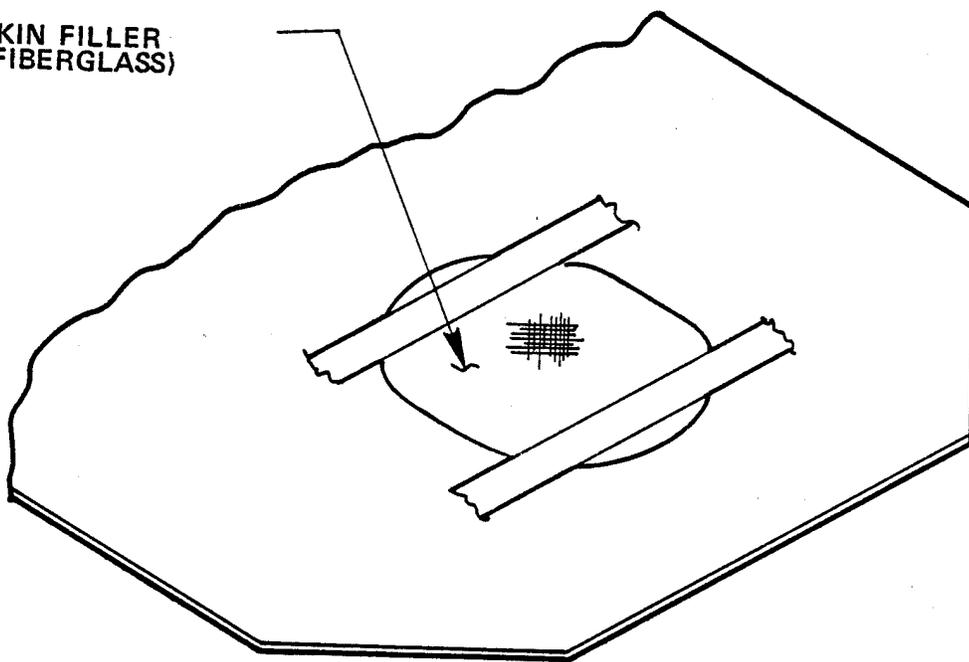
FIGURE 9 SKIN FILLER PATCH LAID UP, FITTED TO
CUTOUT, AND TAPED IN PLACE

- (f) Hold the semi-cured fiberglass patch against the aircraft skin and accurately trace the cutout on the patch. Cut and fit the patch to the cutout and tape it in position. See Figure 9. Use a liberal amount of tape on the exterior skin side to be sure that the patch is securely held. Use spray adhesive and bagging film to seal the exterior surface over the patch.

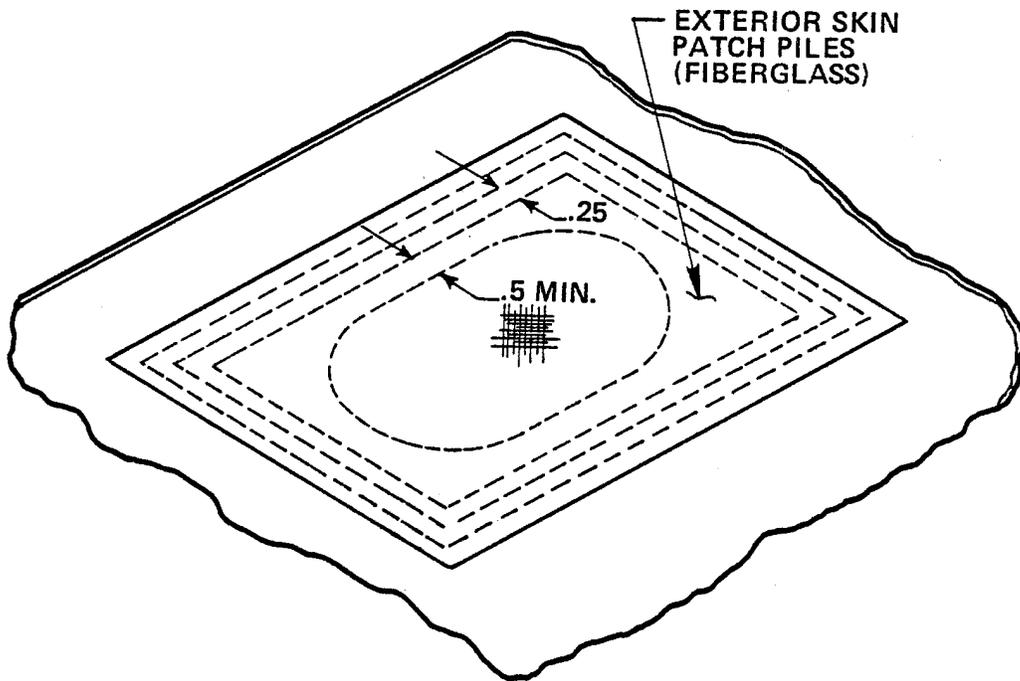
FIGURE 10 EXTERIOR SKIN PATCH LAID UP.

- (a) Remove the bagging film and tape from the exterior side of the skin filler patch. Lay up the four ply exterior skin patch. Start with the second largest ply, centering it over the skin filler patch. Lay up the next two smaller plies to create 6 mm (.25 in.) overlaps as shown in Figure 10. Apply the largest ply last.
- (b) Vacuum bag and cure the repair.
- (c) Clean up and visually inspect the repair.
